# SPOA Road Report

October 6, 2020

Stagecoach Property Owner's Association  
South Stagecoach Subdivisions  
Road Report - Four Points Surveying and Engineering

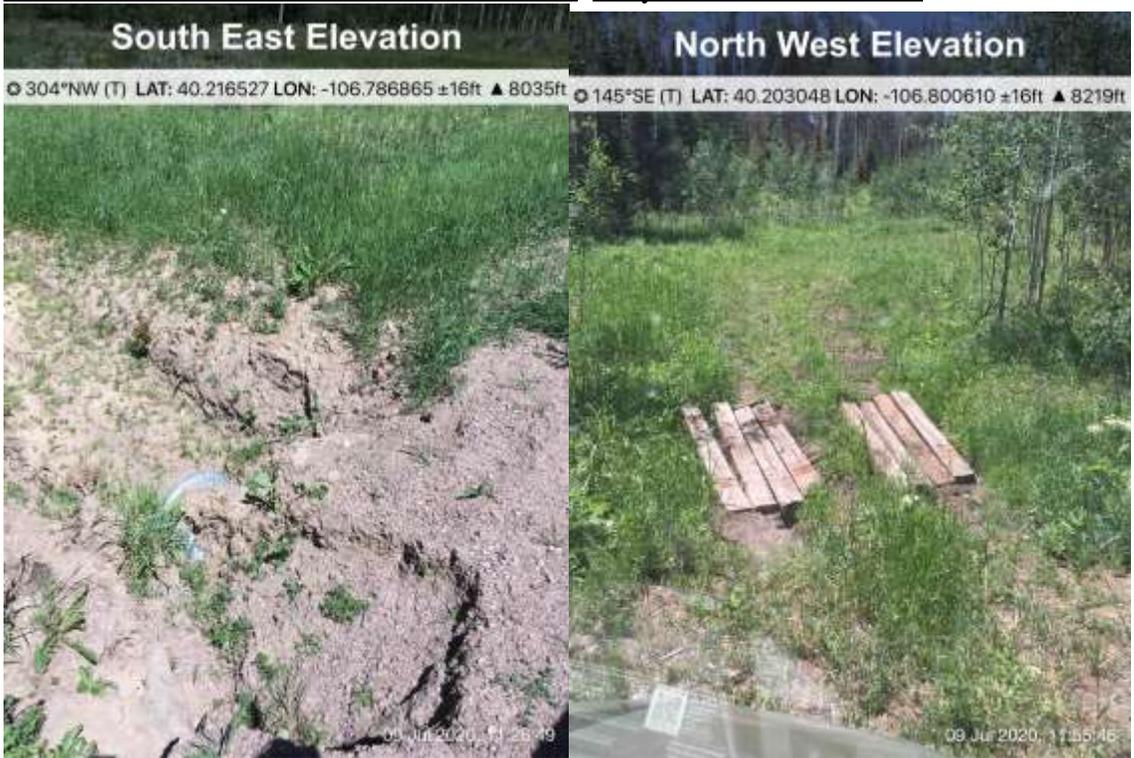
Location	Condition
Seneca, SE of Teton	Sink hole in road
South spur off of Shay, west of Cutter Trail	A homemade wood-slat bridge is present where a culvert likely should be installed
Shay, NE of Haywagon Trail	The road is wet/ has pooled water from poor

Current conditions of the road surface are preventing seasonal access to some properties due to rutting, inadequate drainage (especially in the spring), plugged culvert, or other drainage issues. This is the broadest category of repairs that includes culvert repairs, side drainage improvements, road surface improvements and repairs.

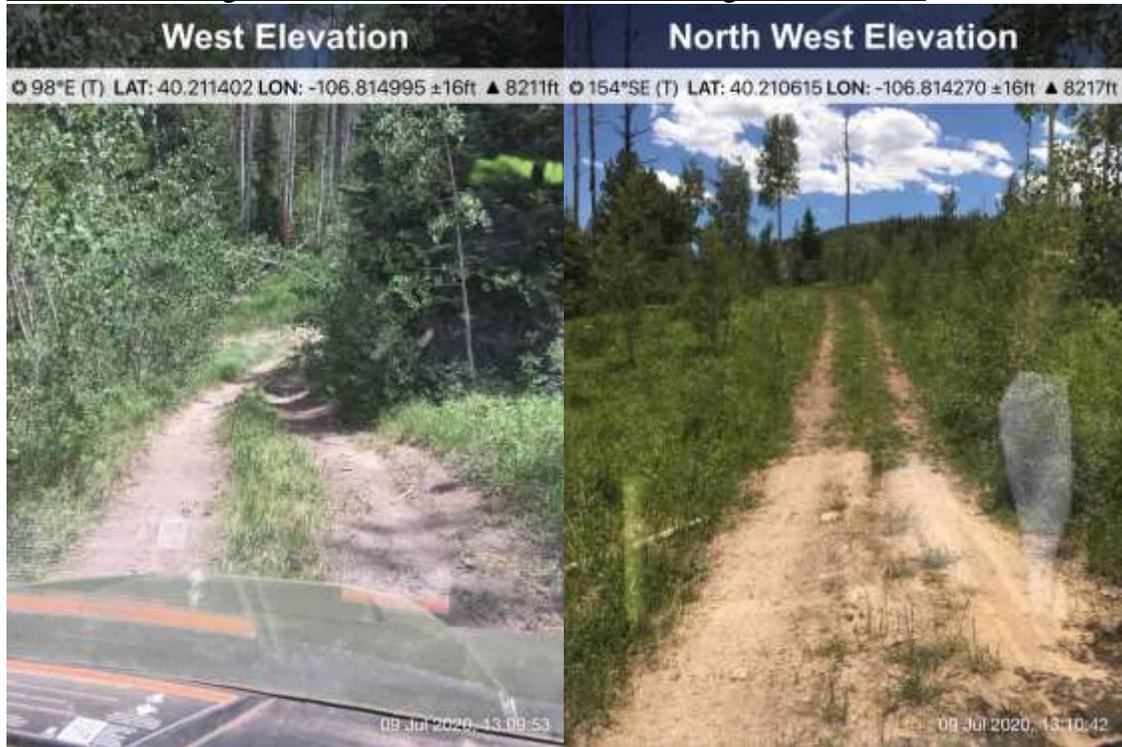
King Bolt S of Colt

Location	Condition
SW circle of King Bolt, S of Springboard Trail, W of Ramuda and N of Trifford	Road is very steep and narrow
Springboard Trail	Rough two-track
King Bolt just S of Colt	Steep section of road
NW Segment of Colt	This segment of Colt is gated, and continuous access is not available to Colt

Typically, these roads are low-quality two-tracks that are accessible only by ATV or other high-clearance 4WD vehicle, and may have grade or width issues, which limits property access. These roads are recommended for grading, clearing and/or blading to allow more access.

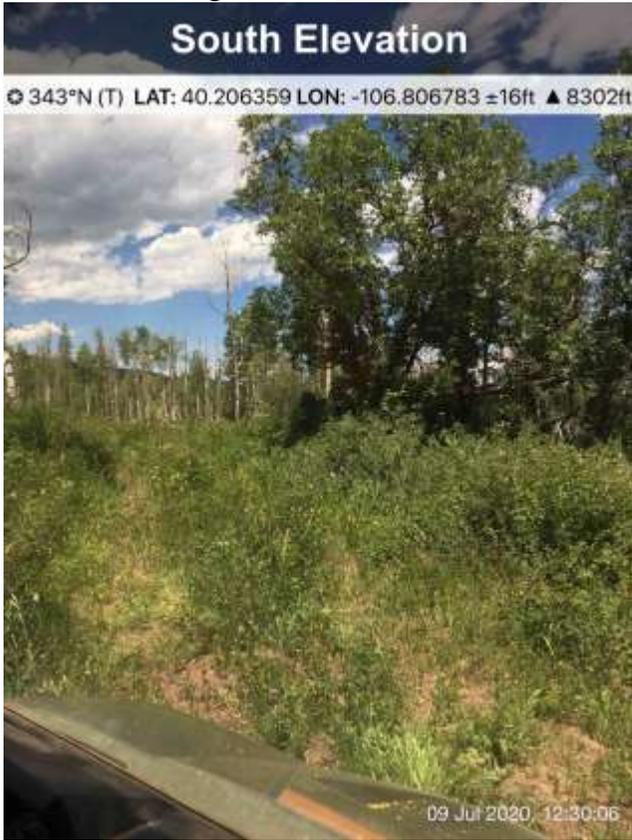
Representative Photos:  
West end of Wagonwheel

Location	Condition
Halter Way to Cody Trail	No apparent roads
Whiffle Tree	South end has not been completed back to connect with Halter
W end of Wagonwheel	Not cut in past the most western "Y" in the road
South Station II cul-de-sacs	Planned roads S of Springboard Trail and S of King Bolt are not cut in.
Halter Way S of Fargo Way	The majority of roads east of Halter and S of Fargo Way do not exist
Blackhorse I	Cul-de-sacs are not cut in for this subdivision

Roads are on the master plan roadway map and within platted subdivisions but were not located in the field. These may have been cut in at one time and regrown over, or not have been cut in at all. These roads are recommended to be cut in as a roadway to allow for seasonal access to properties along these planned roads.
